AIRWORTHINESS DIRECTIVE

Beechcraft 33 and 35-33 (Debonair/Bonanza) Series Aeroplanes

AD/BEECH 33/48
Amdt 1

Forward Elevator Cable

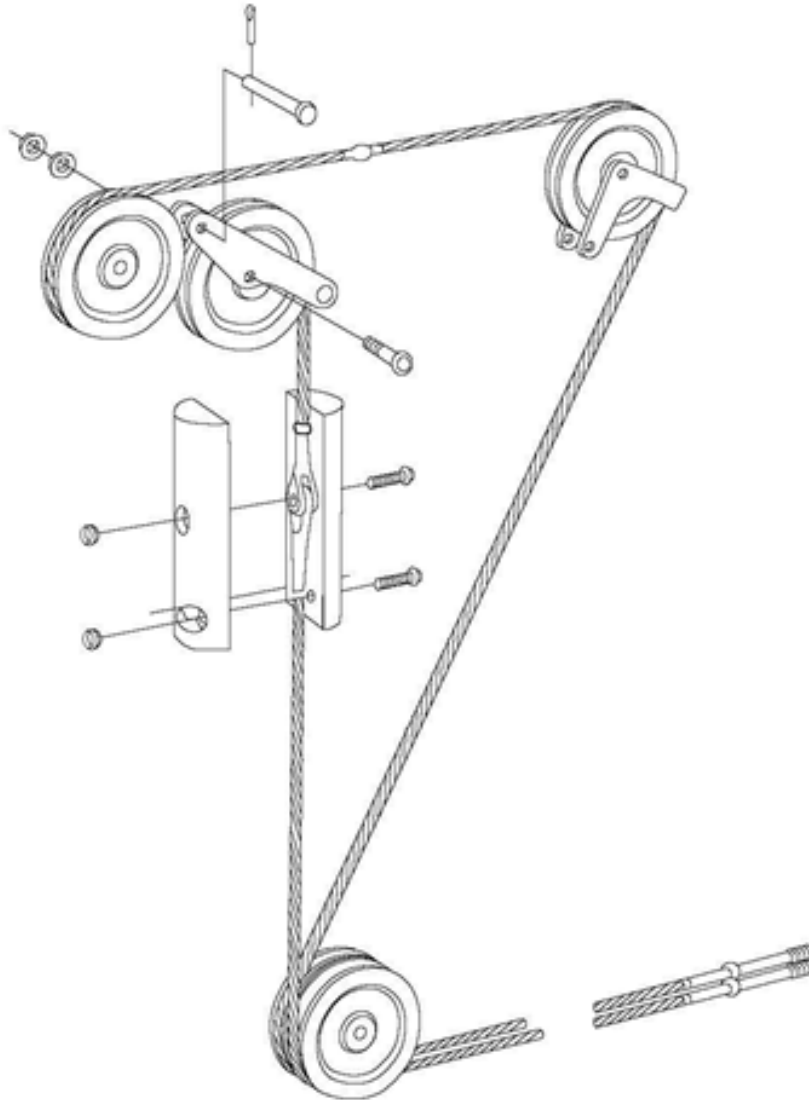
Applicability: All Beechcraft Debonair/Bonanza aeroplanes fitted with the forward elevator control cable configuration as detailed in figure 1 of this AD.

Background: CASA has received a report describing a forward elevator cable failure (separation) immediately prior to take-off. The elevator remained firmly in the full 'down' position due to system spring tension.

A second aircraft was inspected at the owner's request immediately following the discovery of the failed cable. The forward elevator cable in this aircraft was found to be extensively frayed in the same location as the failed cable.

Figure 1 - Forward Elevator Control Cable - Adapted from Beechcraft Illustrated Parts Catalogue.

1. Inspect the forward elevator control cable assembly for wear, broken wires and corrosion; or replace the forward elevator cable assembly.
2. Remove from service any forward elevator control cable assembly found to be defective as a result of inspection conducted in accordance with Requirement 1 of this AD.
3. Do not install on any aircraft a cable assembly or parts thereof that have been removed in accordance with Requirement 2 of this AD.
