All aircraft flight control cable terminal fittings over 15 years old made from stainless steel specification SAE-AISI 303 Se, including, but not limited to, standard terminal part numbers AN669 and MS21260.

The objective of this bulletin is to urge operators and maintainers to consider replacing all control cables having terminal fittings manufactured from stainless steel SAE-AISI 303Se before reaching 15 years time in service.

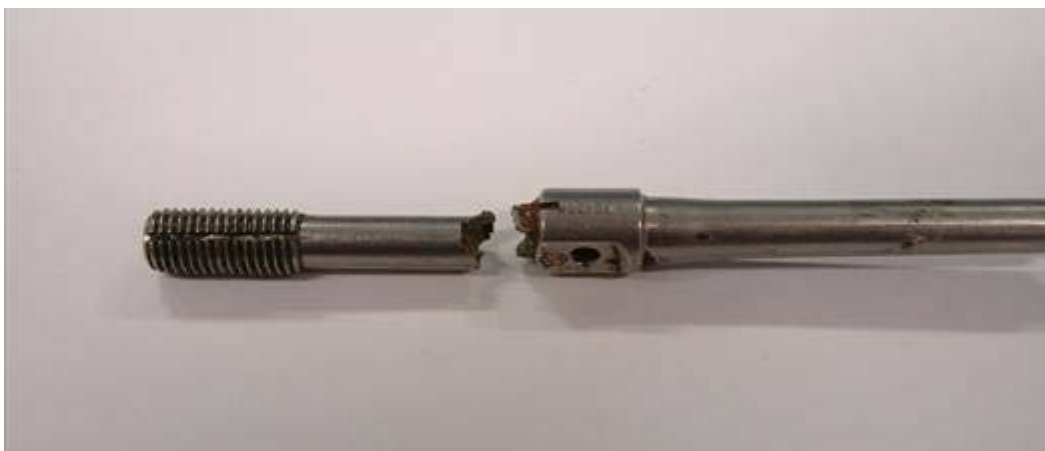
Terminal fitting separation as described in this Airworthiness Bulletin is due to chloride stress-corrosion cracking, a form of intergranular cracking which can originate from within the terminal. Therefore, even very small corrosion pits on the surface of the terminal fitting are indications that the terminal maybe very close to failure.

Figure 1 - Separation at threaded end of terminal

Figures 1 and 2 show how separation failures have occurred at the shaft on the threaded end and at the swaged section of the terminal.

- a. Review the aircraft technical records (Log books) to establish which flight control cables have been replaced in the last 15 years.
- b. Retire all flight control cables made from stainless steel (SAE-AISI 303Se) including, but not limited to, standard flight control cable terminal part numbers AN669 and MS21260, before reaching 15 years time since installation.
- c. Where required by aircraft maintenance documentation, flight control cables should be periodically inspected in accordance with the manufacturer's data and FAA AC 43-13-1B chapter 7, section 8, paragraph 7.149d.

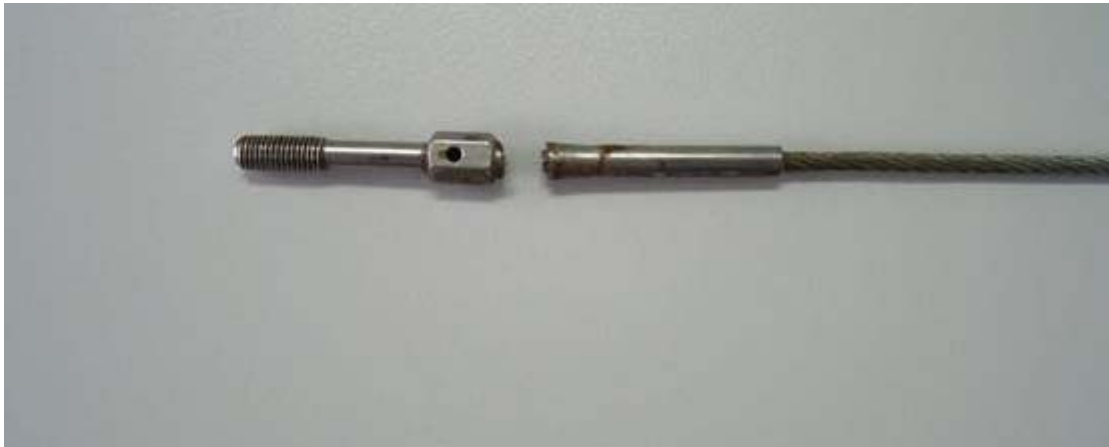
Figure 2 - Separation at swaged end of terminal

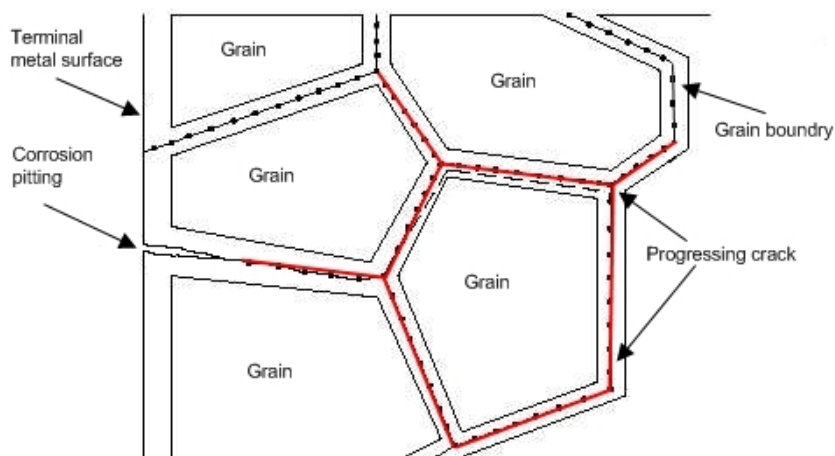
An inspection for pitting on the terminal surface is not considered adequate to determine the extent of the intergranular corrosion that may exist beneath the surface of the terminal, because with this form of corrosion, in this material, the terminal may be close to failure and may even fail, with no visible pitting on the surface.

By the time that surface pitting, however minute, is observed on the surface of the subject terminals, extensive internal corrosion has already taken place in the fitting should be considered unserviceable.

Figure 3 - Intergranular Corrosion Cracking

Figure 3. While the sketch shows surface pitting as evidence of intergranular corrosion, the terminal may be extensively corroded internally and close to failure without any surface pitting.
